Project Type:
Investigation

Project Scope:
Investigation into major equipment failure and recommendations for an optimum remedial solution going forward.

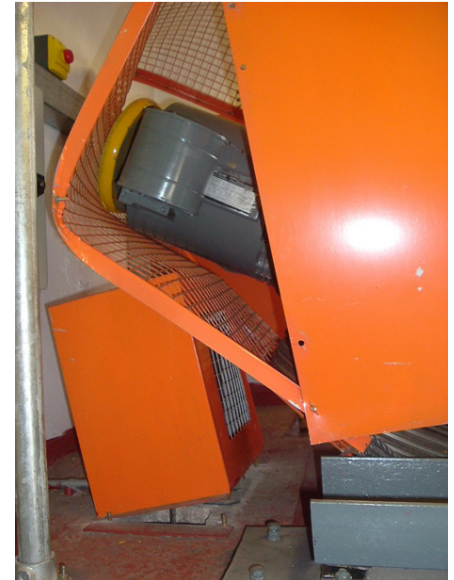
JBA discovered that the rolled steel channel (RSC) fabricated to support the main drive unit had failed at the welded joints, causing the entire drive unit including gearbox, drive motor and traction sheave to collapse to one side.

The whole drive unit had come to rest on the overspeed governor, the only thing that prevented it from falling to the floor. Fortunately nobody was using the lift when the welded joints failed.

The entire drive unit had collapsed

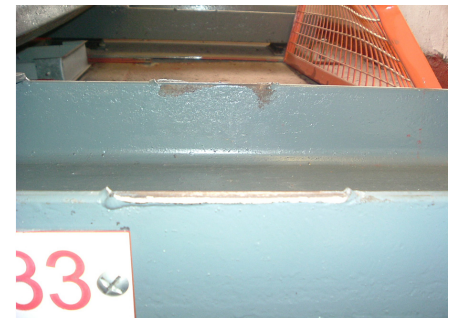
The lift was modernised in 2001 and this included the main drive unit. The supporting steel work was not of the main drive manufacturer's design, appearing to be fabricated to adapt to the existing retained steelwork. Sadly, the welds had not sufficiently penetrated both materials; and the extreme forces exerted on the steel caused the RSC to bend, being only held in place by its fixing bolts.

The welds had not penetrated

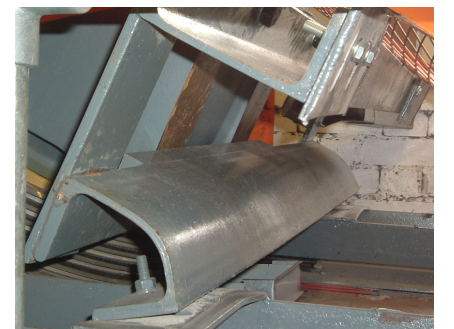
Structural failure
